Cargo Proa Prototype

Building Blog

FEBRUARY 2021

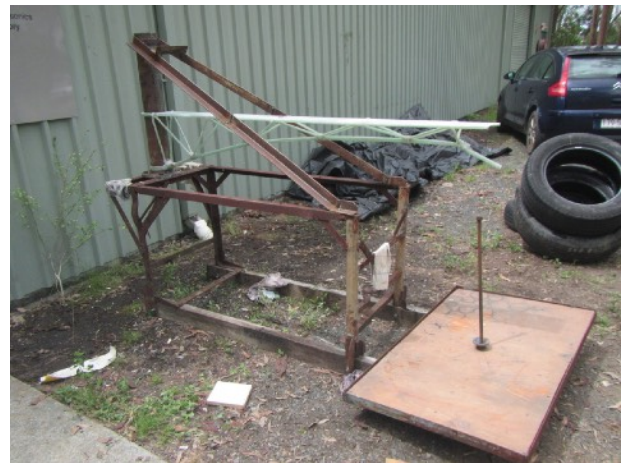
Breakable beam in test rig

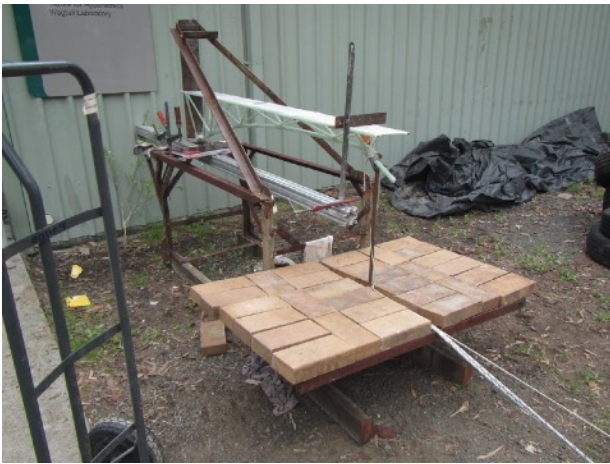
Aprox half design load

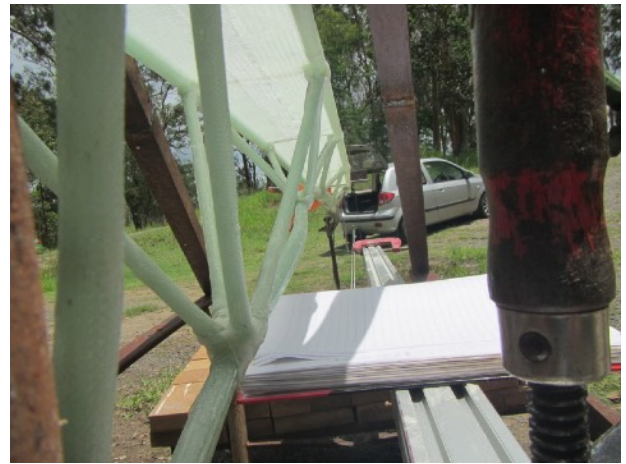
Lower strut distortion

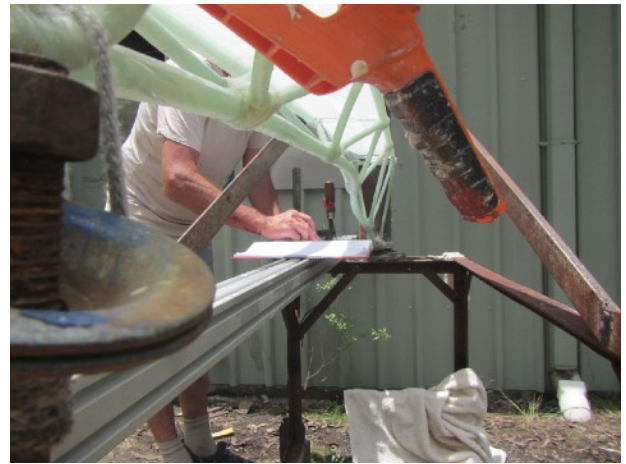
Massive distortion at designed failure load

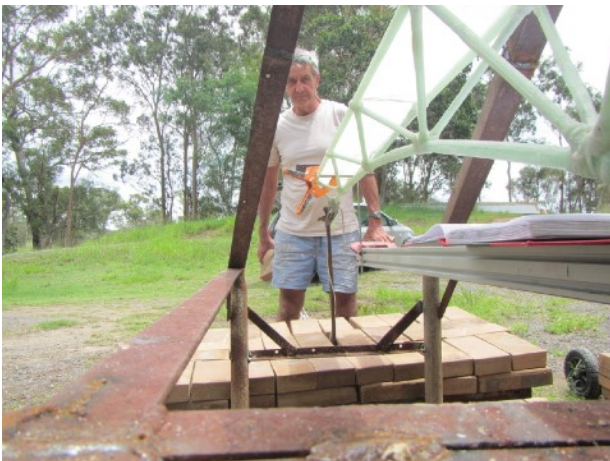
Close to design load

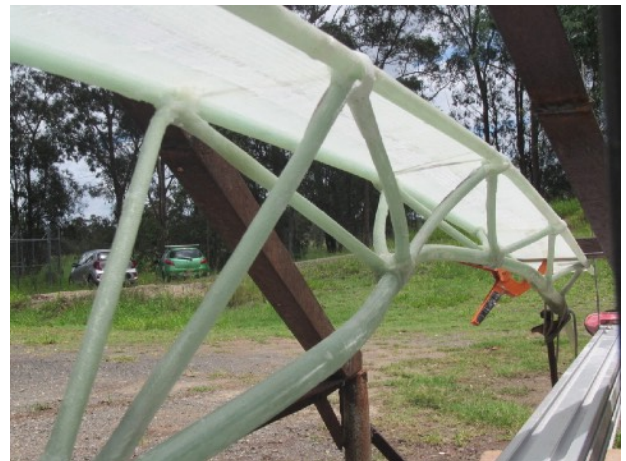
What happens when the web spacings are too large

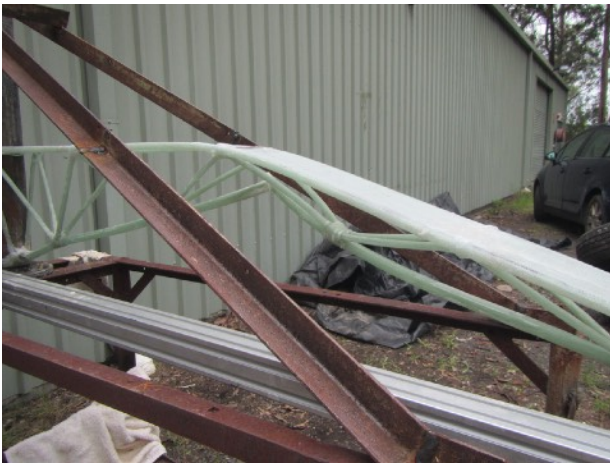
To be honest the beam tested wasn't exactly built to the plan as we couldn't stop ourselves from trying new ideas and making improvements. As can be seen in the photos the top web was replaced with a single piece layup, saving a lot of time, effort and it appeared weight as well. We concluded the top would be in tension for the test so no cross reinforcing was included. We are calling this part of the beam "The walkway" and if it ends up being part of the build it will have cross strengthening where the side web meets the top members. There will be no diagonals as they will be replaced by the walkway. When the load was removed from the broken test beam it straightened up and was able to lift the 20 kg. load tray proving the top and web were still intact and only the lower member had broken.

Crack bang and the load drops to the ground

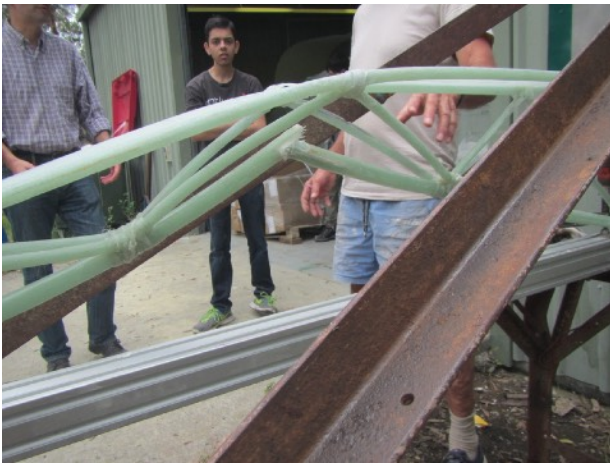
The damage

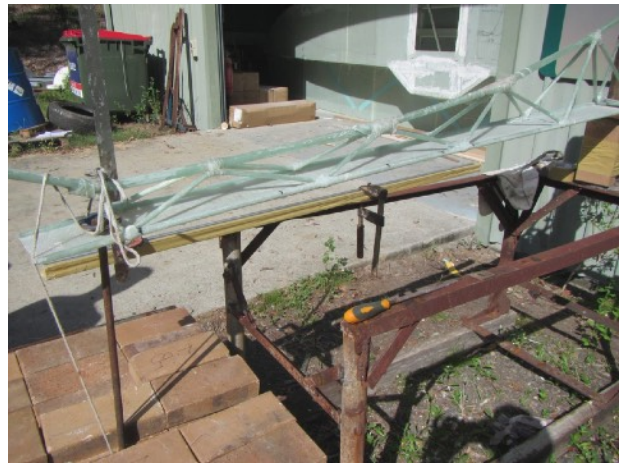
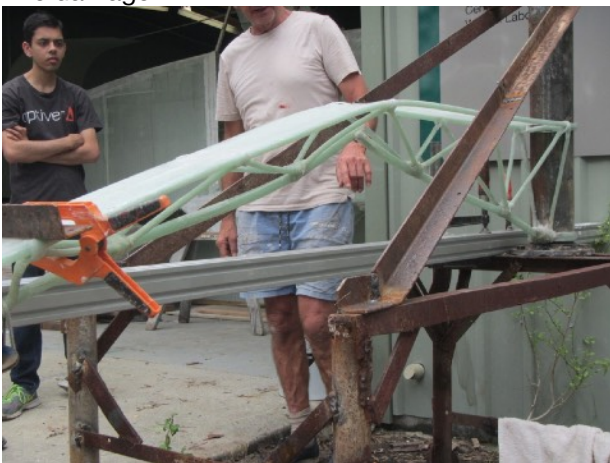
Will it come back straight

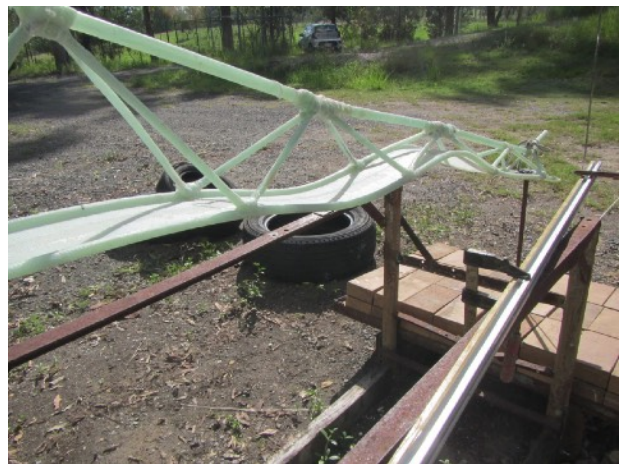
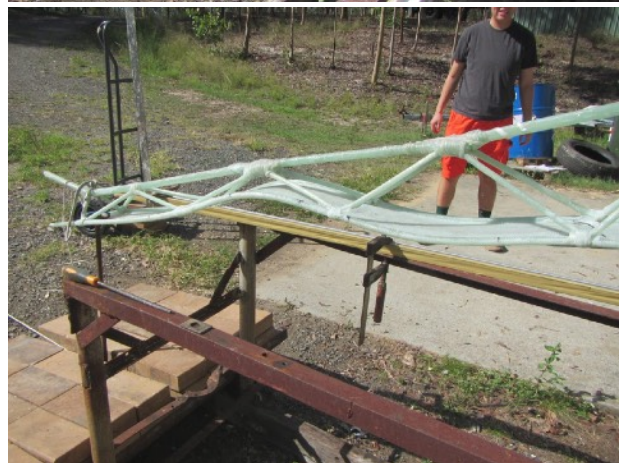
I have since repaired the damage with the intention of testing the beam upside down to see how the walkway and beam behave under negative loads. The pictures tell the story, the load was 1/3rd of the right way up.
